Technical Report REMR-OM-17  
September 1995

# REMR Management Systems—Navigation Structures, Condition Rating Procedures for Tainter Dam and Lock Gates

by *Lowell Greimann, James Stecker, and Mike Nop*  
*Engineering Research Institute*

Engineering Research Institute  
Iowa State University  
Ames, Iowa 50011

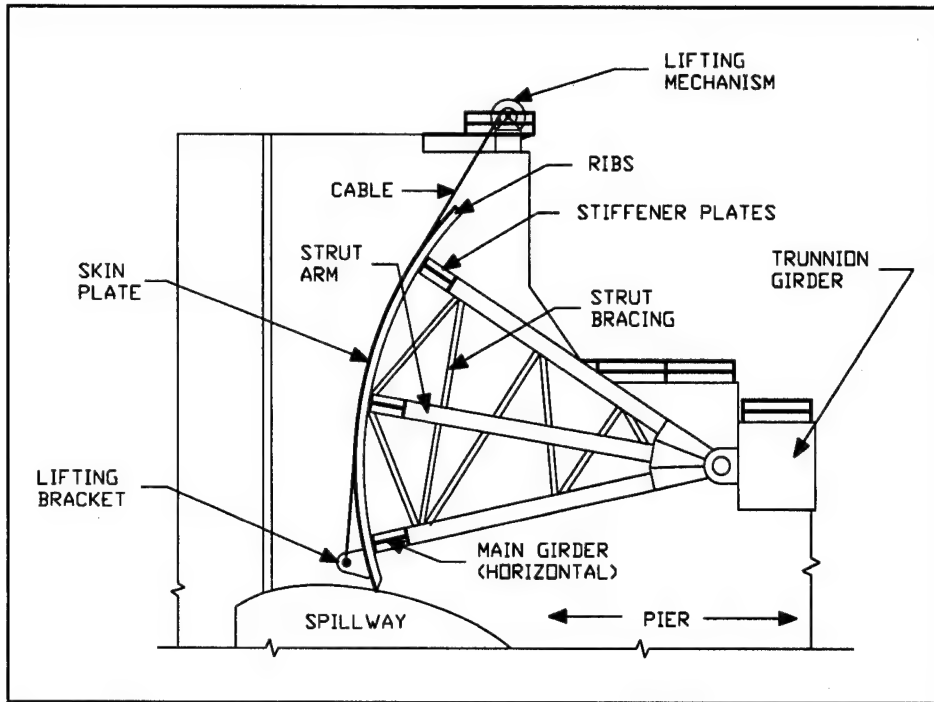
Figure 3. Side view of tainter gate.

**Skin plate:** An upstream skin plate is welded or riveted to the ribs to provide stiffness to the structure (Figures 3, 4, and 5). It dams the water and transfers load to the ribs. A downstream skin plate also may be present.

**Ribs:** The ribs, usually tees, are welded or riveted to the main girders. The ribs transfer load from the skin plate to the main girders (Figures 3, 4, and 5).

**Main girders:** The main girders can be either horizontally or vertically positioned. They span the width or height of the gate and transfer load from the skin plate and ribs to the strut arms (Figures 3, 4, and 5).

**Strut arms:** Strut arms are the steel girders that transfer load from the main girders to the trunnion assembly (Figures 3, 4, and 6). Some strut arms are parallel to the pier face and some slope toward the center of the gate from the trunnion, as shown in the figures.

**Trunnion girder:** The concrete or steel trunnion girder is anchored into the pier or lockwall (Figures 3 and 6). It transfers load from the trunnion yoke to the pier or lockwall.

**Lifting chain or cable:** The lifting chain or cable connects the operating machinery with the gate (Figure 3). It moves the gate between its open and closed positions.

**Lifting bracket:** The lifting brackets are located near the bottom of the gate on either the upstream or downstream side of the skin plate. They connect the chain or cable to the gate structure (Figures 3 and 4).

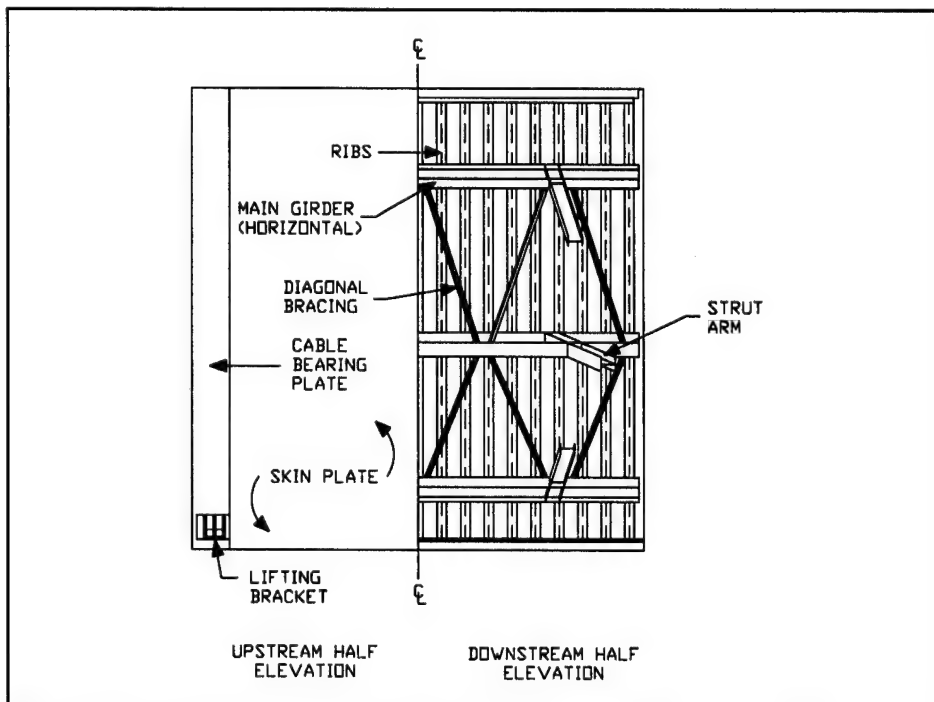
Figure 4. Elevation view of tainter gate.

**Cable or chain bearing plate:** A bearing plate is a thickened or doubled strip of the skin plate or back-to-back channels located on the upstream side (Figure 4). It reduces the wear on the skin plate caused by the sliding contact of the cable or chain as the gate is moved.

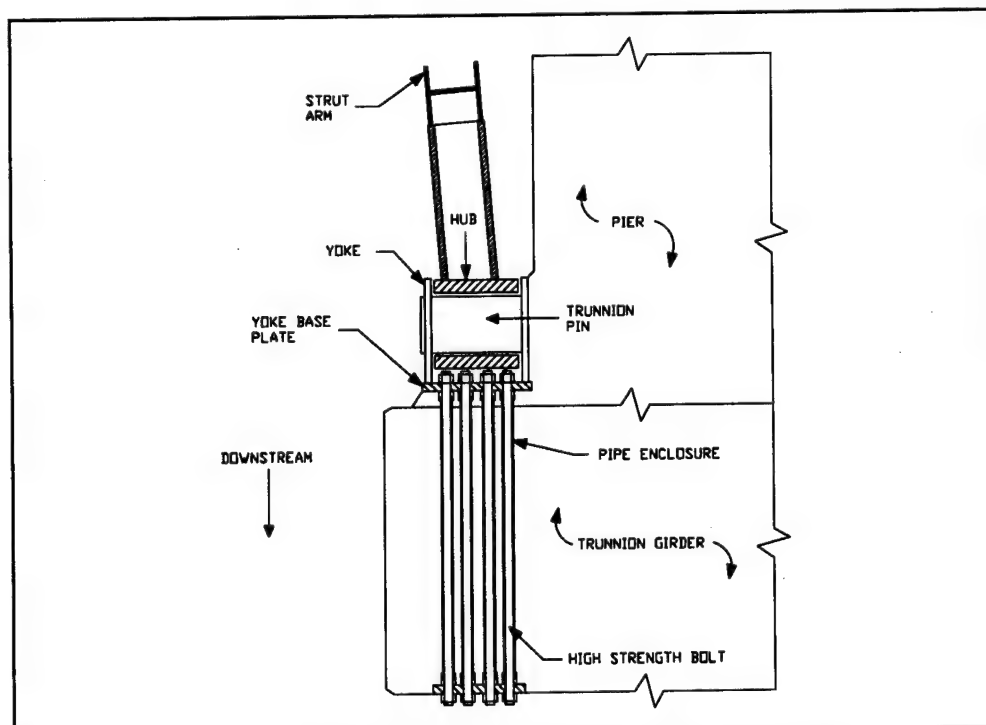
Figure 6. Example trunnion assembly detail (individual projects differ considerably).

**Trunnion assembly:** The trunnion assembly consists of a trunnion hub with bronze bushing and heavy flanges, a trunnion yoke, and a trunnion pin (Figure 6). The trunnion assembly transfers load from the strut arms to the trunnion girder.

**Trunnion hub:** The trunnion hub consists of a cylindrical plate and bushing which encompass the hinge pin and transmit load from the strut arms to the trunnion yoke (Figure 6). The flanges align the strut.

**Trunnion yoke:** The trunnion yoke is bolted to the concrete or steel trunnion girder (Figure 6). It transfers load from the trunnion hub to the trunnion girder.

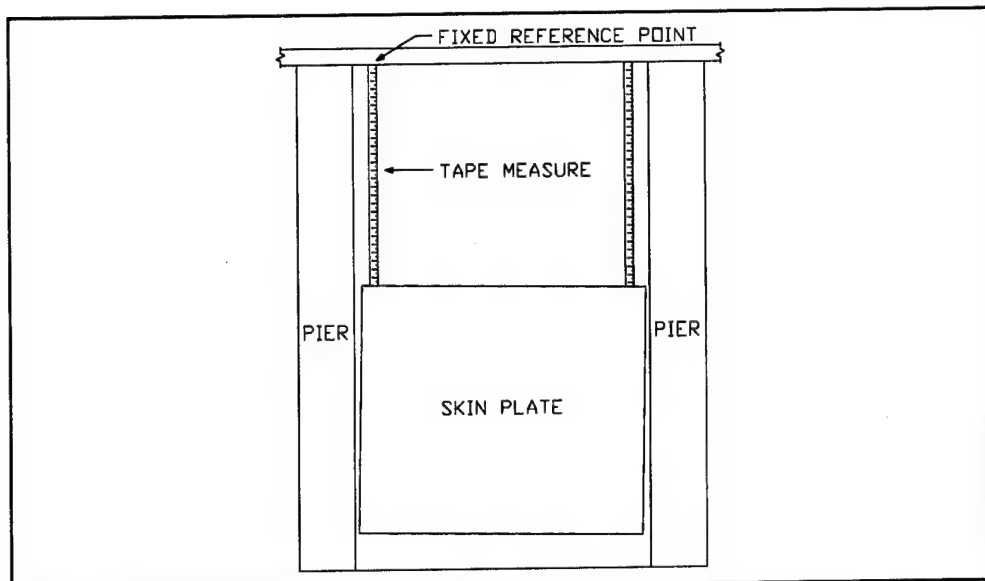
**Figure 7. Misalignment measurement.**

**MISALIGNMENT:** Measurements are recorded with the gate in the closed and 2 ft. open positions and then again in the closed position. Measurements can be made by attaching a tape measure to the skin plate on each side of the gate and recording the distance from a fixed reference point above the gate to the top of the gate (Figure 7). An alternative method of measurement consists of placing an electronic level horizontally along the skin plate and recording the angles (in degrees) at each gate position. (Levels should measure angles to the nearest 0.001 degrees.)

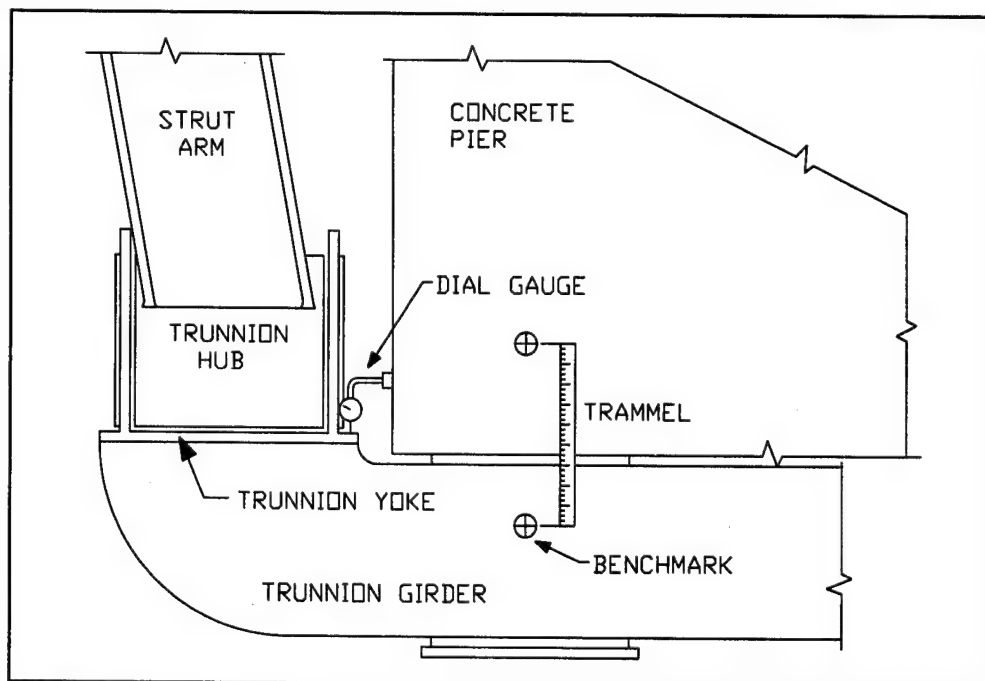
**Figure 8. Anchorage measurement.**

**ANCHORAGE MEASUREMENT:** Measurements of relative movement between the concrete pier and trunnion yoke or girder are taken in the downstream direction (Figure 8). If the inspection is performed under **NORMAL OPERATING CONDITIONS**, dial gauges are used to measure this movement and measurements are taken with the gate in the closed and 2 ft. open positions and then again in the closed position. For tracking relative movement over time, permanent reference points or benchmarks are established on the trunnion girder and on the pier adjacent to the girder. The distance between these points are recorded with the gate in the closed position after the gate has been lifted and reset. A convenient means of doing this is by using a trammel with permanently fixed trammel points for benchmarks. If **BULKHEADED CONDITIONS** exist, dial gauge measurements are taken in the closed position with no head on the gate and with full head on the gate. The term, no head, implies that the water on the upstream face of the gate will be removed by opening the gate. If a tailwater is present on the gate, the upper pool will be equal to the level of the lower pool with no net head. To apply full head or load, lift the bulkhead and flood the gate. Dial gauge measurements should be recorded to 0.001 inch. Trammel measurements between the permanent reference points are taken in the no head condition. Trammel measurements should be recorded as accurately as possible (about 0.0313 in. or 1/32 in.).

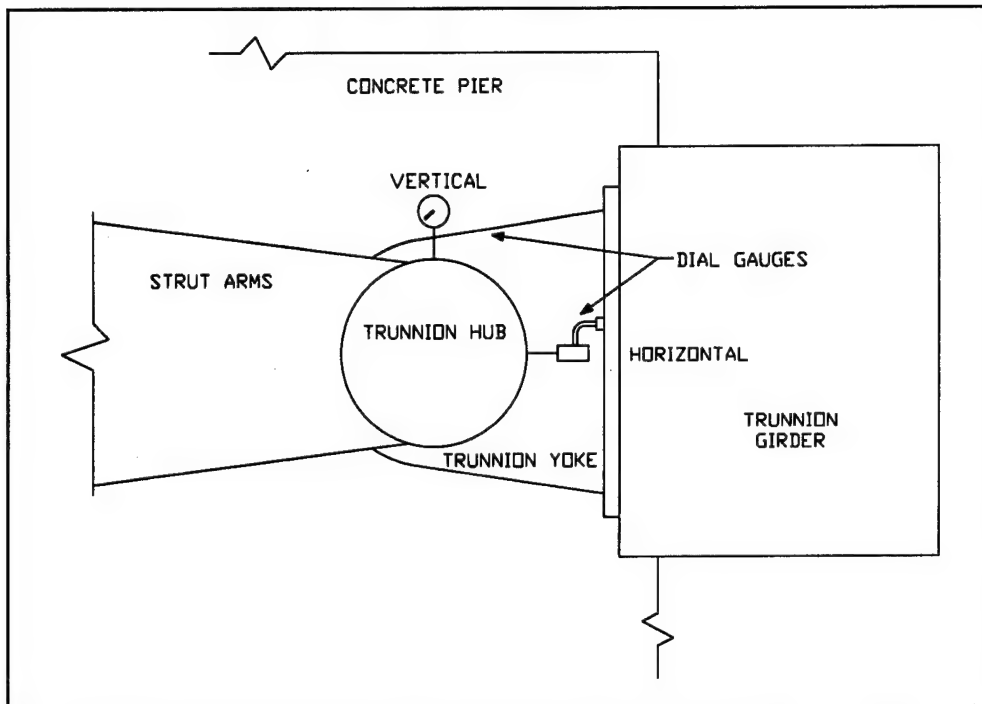
**Figure 9. Trunnion assembly wear measurement: dial gauges.**

For an inspection performed under **NORMAL OPERATING CONDITIONS** the horizontal and vertical measurements are made with the gate in the closed and 2 ft. open positions and then again in the closed position. If dial gauges are used to measure the horizontal and vertical movement, it is important that the bearing surface for the dial gauge stem be smooth, with no unevenness, since the trunnion hub rotates. If feeler gauges are used, gap measurements are taken between the pin and bushing in four locations: upstream, downstream, top, and bottom. Horizontal trammel measurements are taken between permanent reference points or benchmarks which have been established in convenient positions on the trunnion hub and yoke. Trammel measurements are recorded in the closed position after the gate has been lifted and reset. Estimate lateral movements and circle correct answer. Gouging occurs when the trunnion hub bears on the trunnion yoke.

The measurements taken in the horizontal,  $X_{HOR}$ , and vertical,  $X_{VER}$ , directions can be made using feeler or dial gauges and trammels (Figures 9, 10, 11). The total motion, no matter what measuring device is used, is calculated by taking the square root of the sum of the squares of the horizontal and vertical movements in each direction:

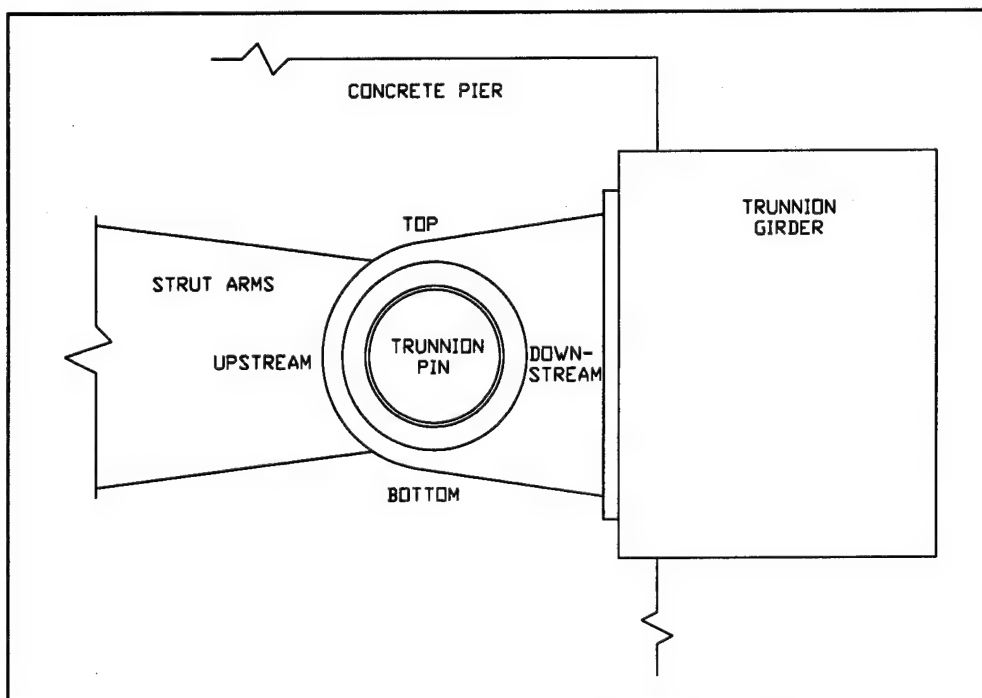
**Figure 10. Trunnion assembly wear measurement: feeler gauges.**

Under **BULKHEADED CONDITIONS** the measurements will be recorded with the gate in the closed position when no head or load is present on the gate and when full head exists. If feeler gauges are used, gap measurements shall be taken between the pin and bushing in the same locations as under **NORMAL OPERATING CONDITIONS**. If dial gauges are used, no special precautions are required to ensure a smooth bearing surface for the stem because the trunnion hub will not rotate. Horizontal trammel measurements are also taken between the permanent reference points for the no head condition.

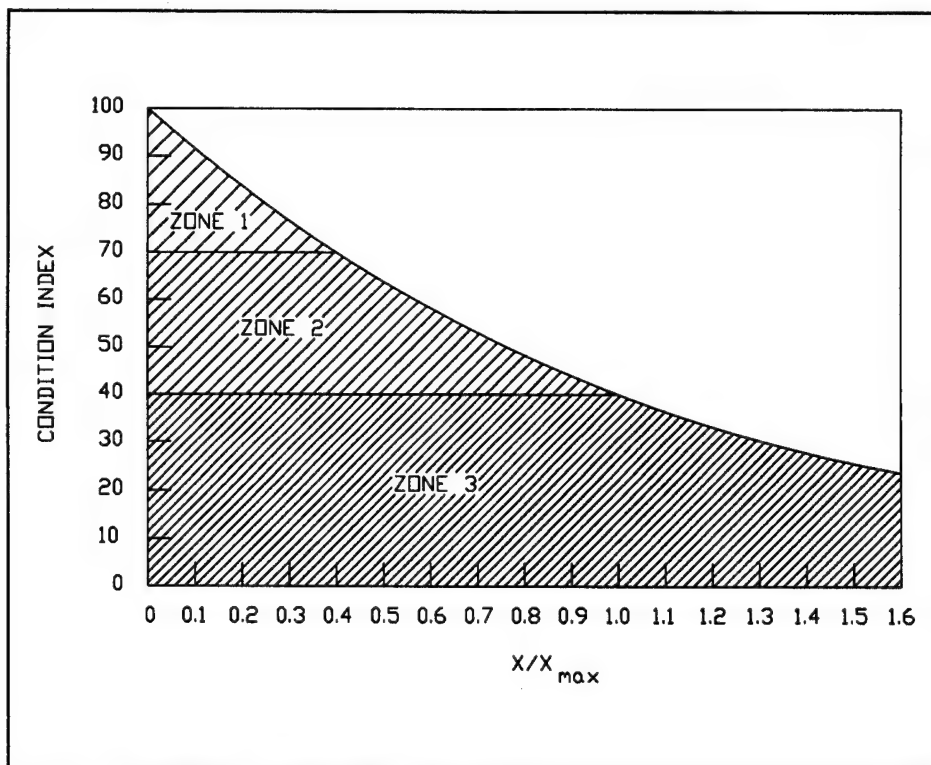
**Figure 13. Condition index related to  $X/X_{max}$ .**

where  $X_{max}$  is some limiting value of  $X$ . The CI zones given in Table 2 define  $X_{max}$  as the point at which the CI is 40, that is, the dividing point between Zones 2 and 3. In other words, the experts have chosen the limiting value  $X_{max}$  to be the point at which a tainter gate requires immediate repair or, at least, a more detailed inspection. Figure 13 illustrates the equation and zones from Table 2.

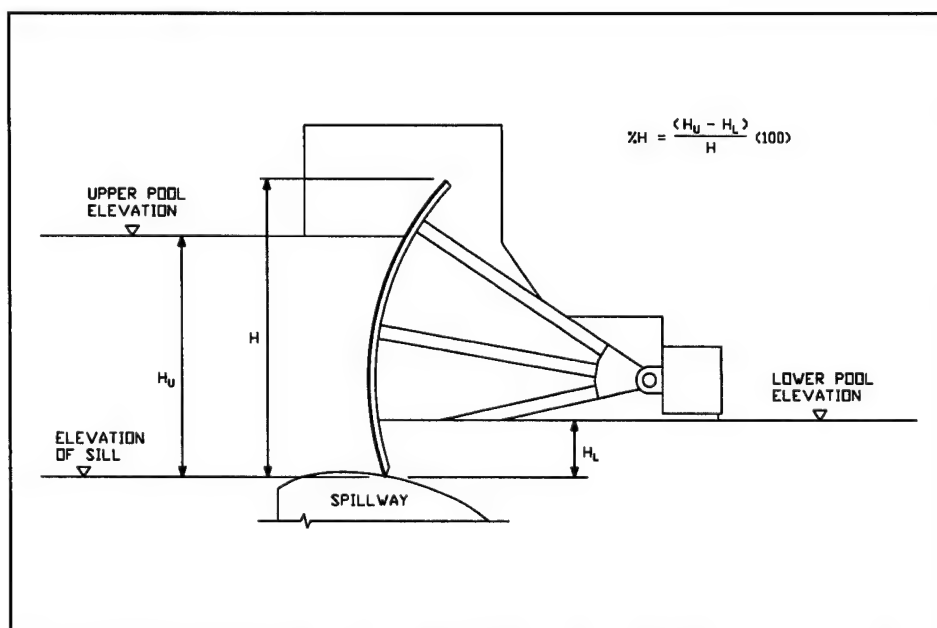
Figure 14. Percent head with tailwater.

**Bulkheaded conditions:** Dial gauges are used to measure short-term movement under bulkheaded conditions. This displacement,  $X_s$ , is the difference between the full-head and no-head readings. The limiting value is dependent upon the percent of head present on the gate, %H, which is equal to the head applied to the gate when the bulkhead is removed, expressed as a percent of gate height, H (Figures 14 and 15). For a rigid anchorage, the limiting values are, if there is less than 20 percent head on the gate,

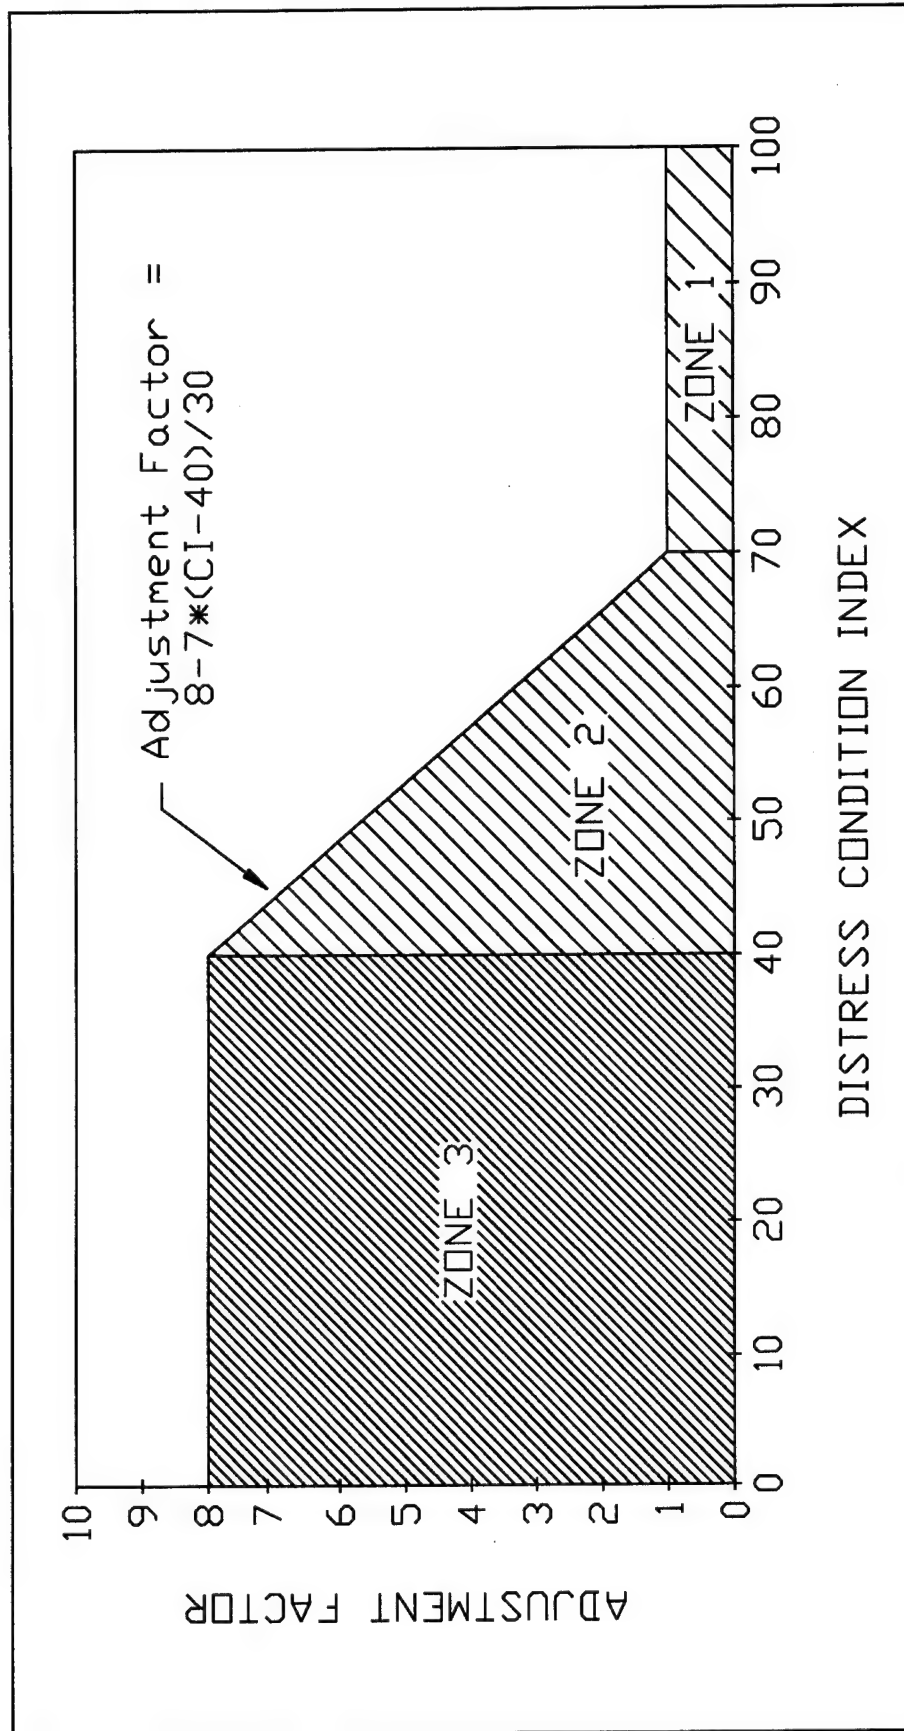
Figure 16. Weight adjustment factor for condition index.

Previous work done by the ISU project team has established that the relative importance of a distress should be greater as the distress becomes more severe. This concept is established by introducing a variable adjustment factor, which will increase the distress weighting factor  $w_i$  as its CI approaches Zone 3. The adjustment factor plotted in Figure 16 has a maximum value of eight; that is, if a distress has a CI that is less than 40, its importance increases eight times.

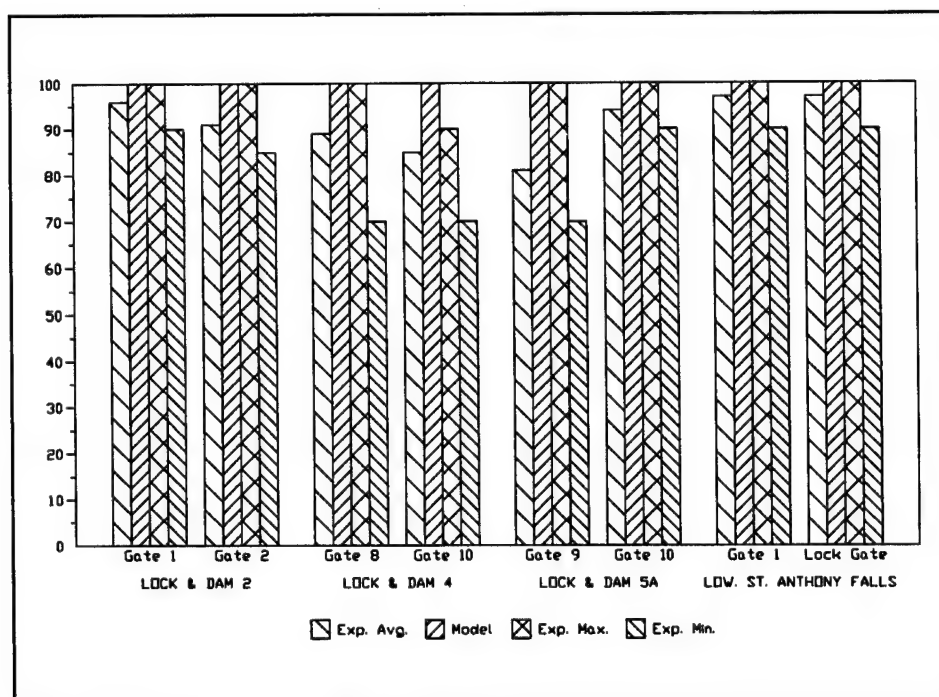
Figure 18. Noise, jumping, and vibration.

Because no abnormal noise, jumping, or vibration was recorded, the calculated CI values were 100. Although no abnormal distress information was recorded, the experts did not give this distress a perfect rating. Normal vibration was observed on Gate 2 at Lock and Dam (L&D) 2 and on Gate 10 at L&D 4; also, normal noise and vibration were observed on Gate 9 at L&D 5A. The experts may have rated this distress lower than 100, particularly on the gates where normal occurrences were observed, because they did not feel that a distress CI should be 100 if the structure was not new. This phenomena is consistent with what experts have felt about previous structures. Gate 8 at L&D 4 has an expert average rating of 89, which is unexplainably low because no normal or abnormal occurrences of this distress were recorded.

The following bar charts (Figures 18 to 25) present the experts' subjective CI versus the CI calculated by Chapter 3 rules for the distresses associated with tainter dam and lock gates. Each graph is for an individual distress. Within each group of data are four columns of data that represent

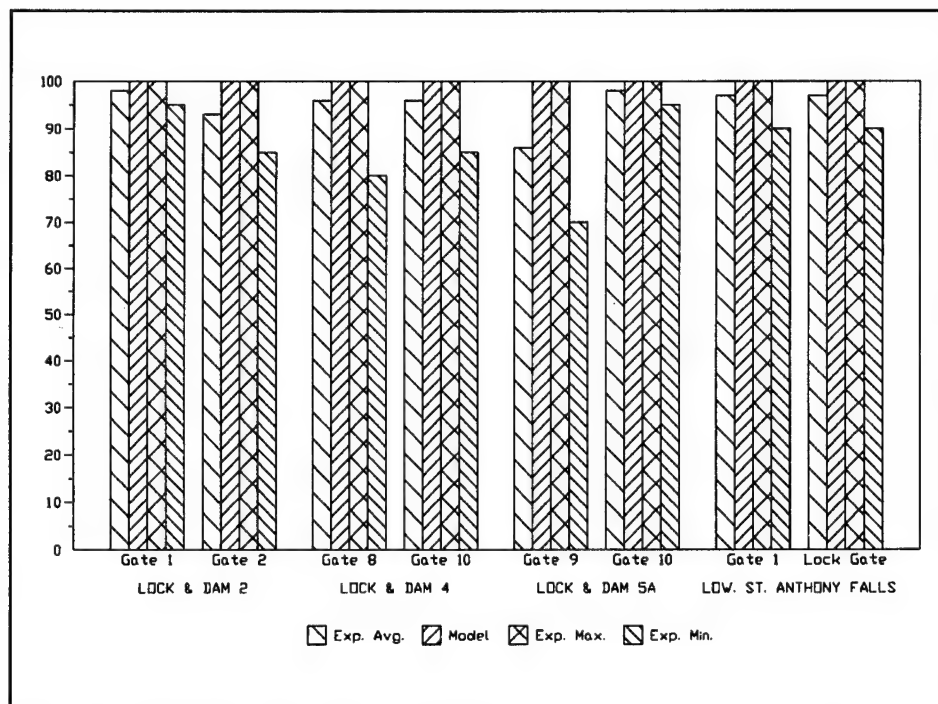
Figure 19. Vibration with flow summary.

Again the calculated CIs for each gate were 100 and the experts rated the gate lower. Level 1 gate vibration was experienced on Gate 2 at L&D 2 and on Gate 9 at L&D 5A, which explains the lower-than-normal expert average rating for these two gates. However, the vibration disappeared when the position of the gates was adjusted and, therefore, the calculated CI was 100.

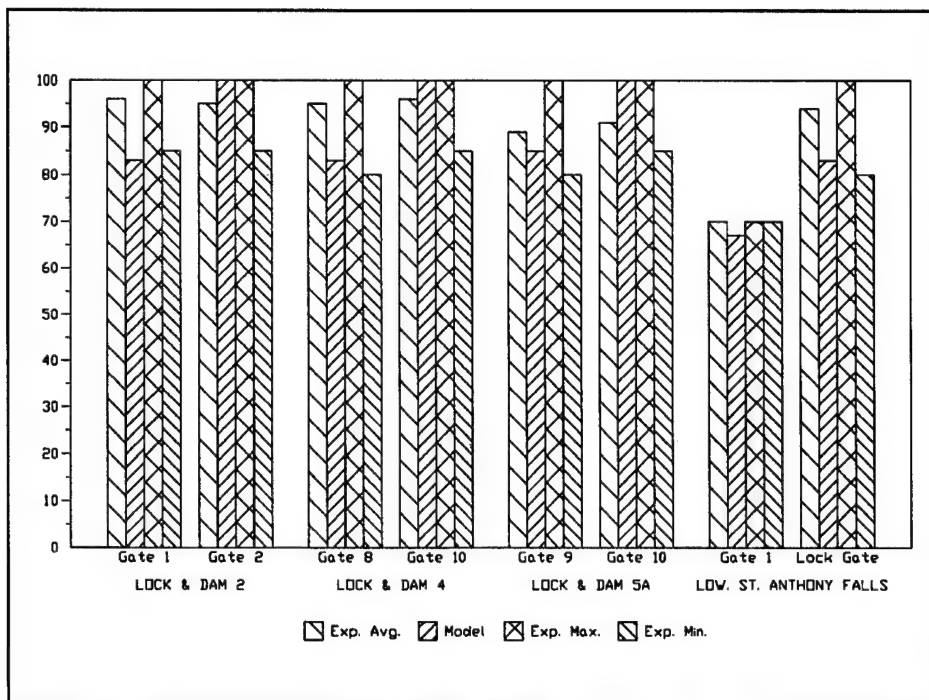
**Figure 20. Anchorage assembly deterioration.**

The calculated anchorage assembly CIs closely approximated the expert averages, except for Gate 1 at L&D 2, Gate 8 at L&D 4, and the lock gate at Lower St. Anthony Falls. Movements of 0.001 in. were recorded for Gates 1 and 8, which result in a calculated CI of 83. The experts assigned a limiting  $X_{max}$  value of 0.005 in. for rigid anchorage motion under normal operating conditions. However, the higher CIs assigned by the experts do not support the appropriateness of this limiting value, and suggest that  $X_{max}$  should be increased. Nevertheless, the authors feel that the movement is significant, especially because the load variation on the gate is small under a normal operating condition, and that the calculated CI is appropriate. The calculated CI for the lock gate at Lower St. Anthony Falls was 11 points lower than the expert average. The limiting value for flexible anchorage movement is 0.065 in. using Eq. 3.16 with an embedment length,  $L$ , of 9 ft, which is

the length of the W-beam (Figure 17). The movement measured during the inspection was 0.013 in. The calculated CI would more closely approximate the expert average if the rule, which is based on an allowable axial deformation, included the deformation of the 5-ft box trunnion girder. However, the authors feel that the anchorage configuration is unique, and therefore an analysis is not warranted. Long term movements could not be determined because only current readings were available. The accuracy of trammel measurements may not be sufficient.

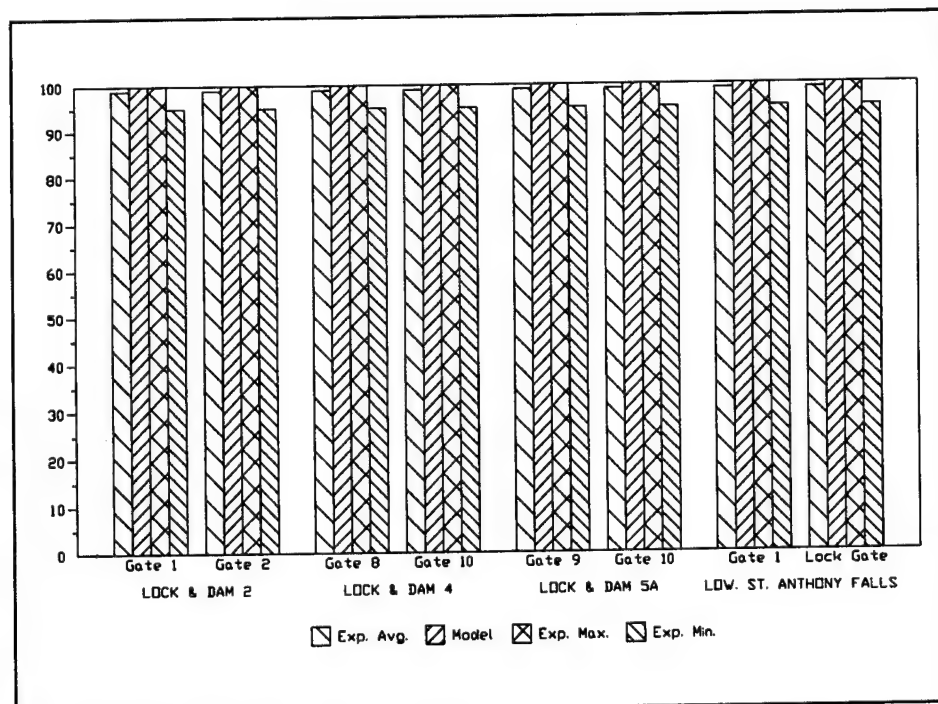
Figure 22. Cracks.

No cracks were recorded on any gate, resulting in a calculated CI of 100 for the crack distress on each gate. Similar to the noise, jumping, and vibration distress, though, the experts rated the gates slightly lower than 100.

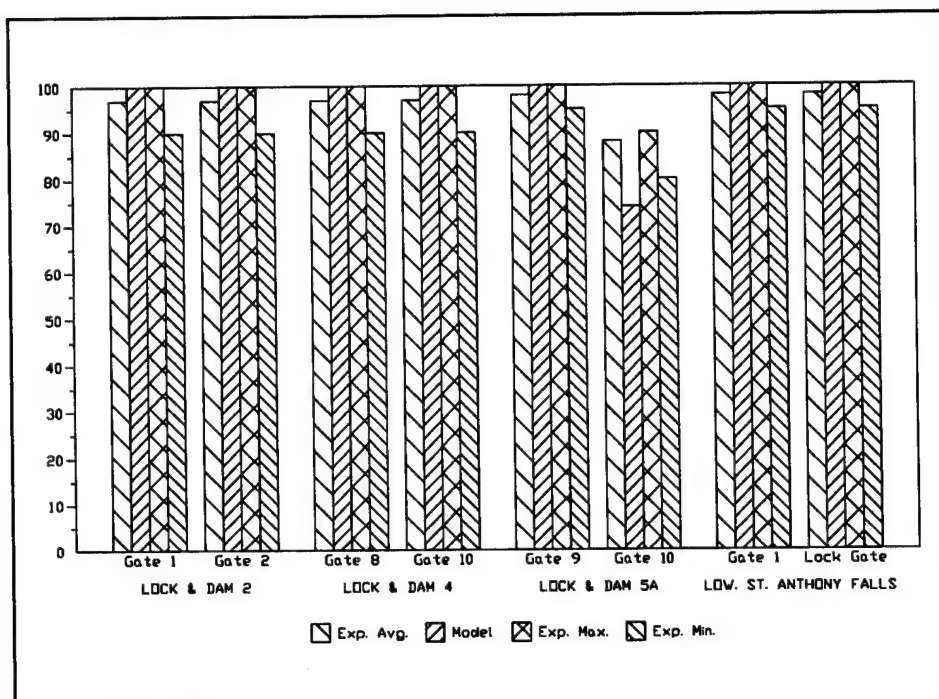
Figure 23. Dents.

The only dents recorded in the field test (three on the skin plate and one on the ribs) were on Gate 10 at Lock and Dam 5A. The calculated CI describing the dent condition was 14 points lower than the expert average for this gate. This calculated CI was controlled by the rib dent; however, the CI calculated for the skin dents was only two points higher at 76. As future inspections are performed, it may be necessary to increase the value of  $X_{max}$  to better reflect the condition of a gate. The more conservative  $X_{max}$  is appropriate at this time.

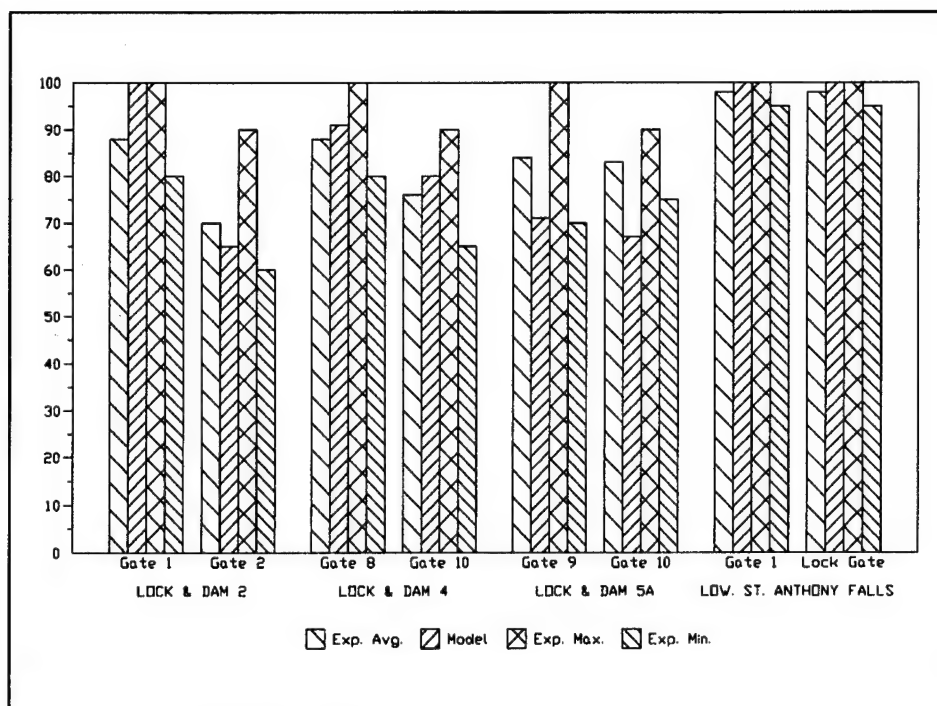
Figure 24. Corrosion/erosion.

No corrosion or erosion was recorded on Gate 1 at L&D 2 and the gates at Lower St. Anthony Falls. The expert average for Gate 1 at L&D 2 cannot be accounted for by the authors. Strut arm corrosion was the controlling CI for Gate 10 at L&D 4 and the gates at L&D 5A. The calculated CI for Gate 10 at L&D 4 compared well with the expert average. The gates at L&D 5A, however, had calculated CIs that were substantially lower than the expert average. The calculated CI values for Gate 2 at L&D 2 and Gate 8 at L&D 4 correspond relatively well with the expert averages. The corrosion was recorded on the inspection form using primarily the percentage area method.

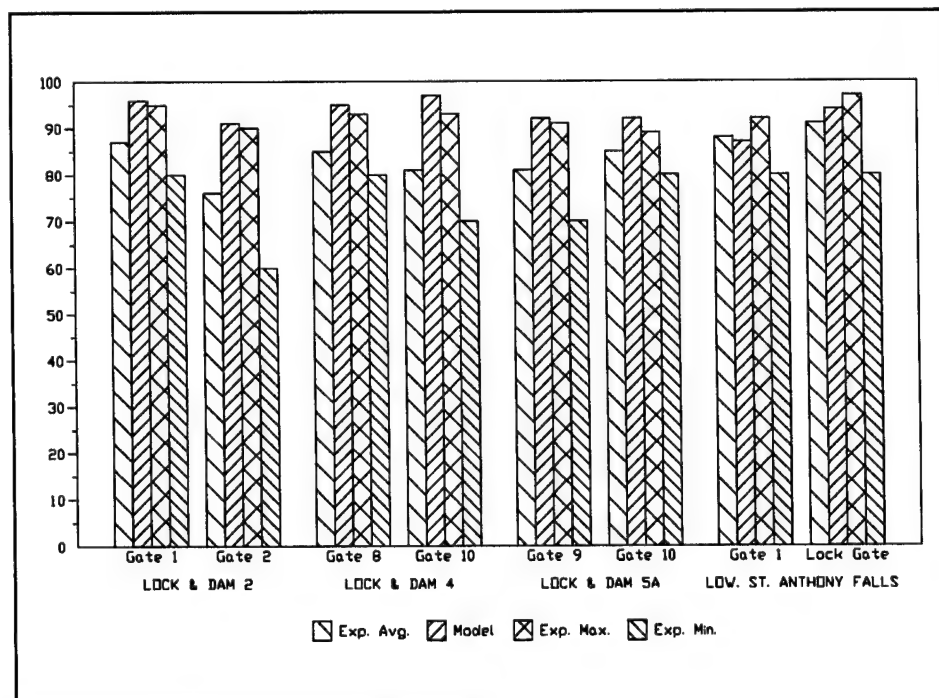
Figure 26. Overall ratings for the gates.

The overall gate ratings from the calculated model tended to track higher than the expert average, except for Gate 1 at Lower St. Anthony Falls, which was

slightly lower. The primary reason that most calculated CIs were higher is that the experts based their overall gate rating on the lowest individual distress CIs, generally leak and corrosion CIs, without considering the other distresses.
